THAMES RIVER BASIN
WINDHAM, CONNECTICUT
BIG POND DAM
CT 00194

PHASE I INSPECTION REPORT
NATIONAL DAM INSPECTION PROGRAM

DEPARTMENT OF THE ARMY
NEW ENGLAND DIVISION, CORPS OF ENGINEERS
WALTHAM, MASS. 02154

AUGUST 1980

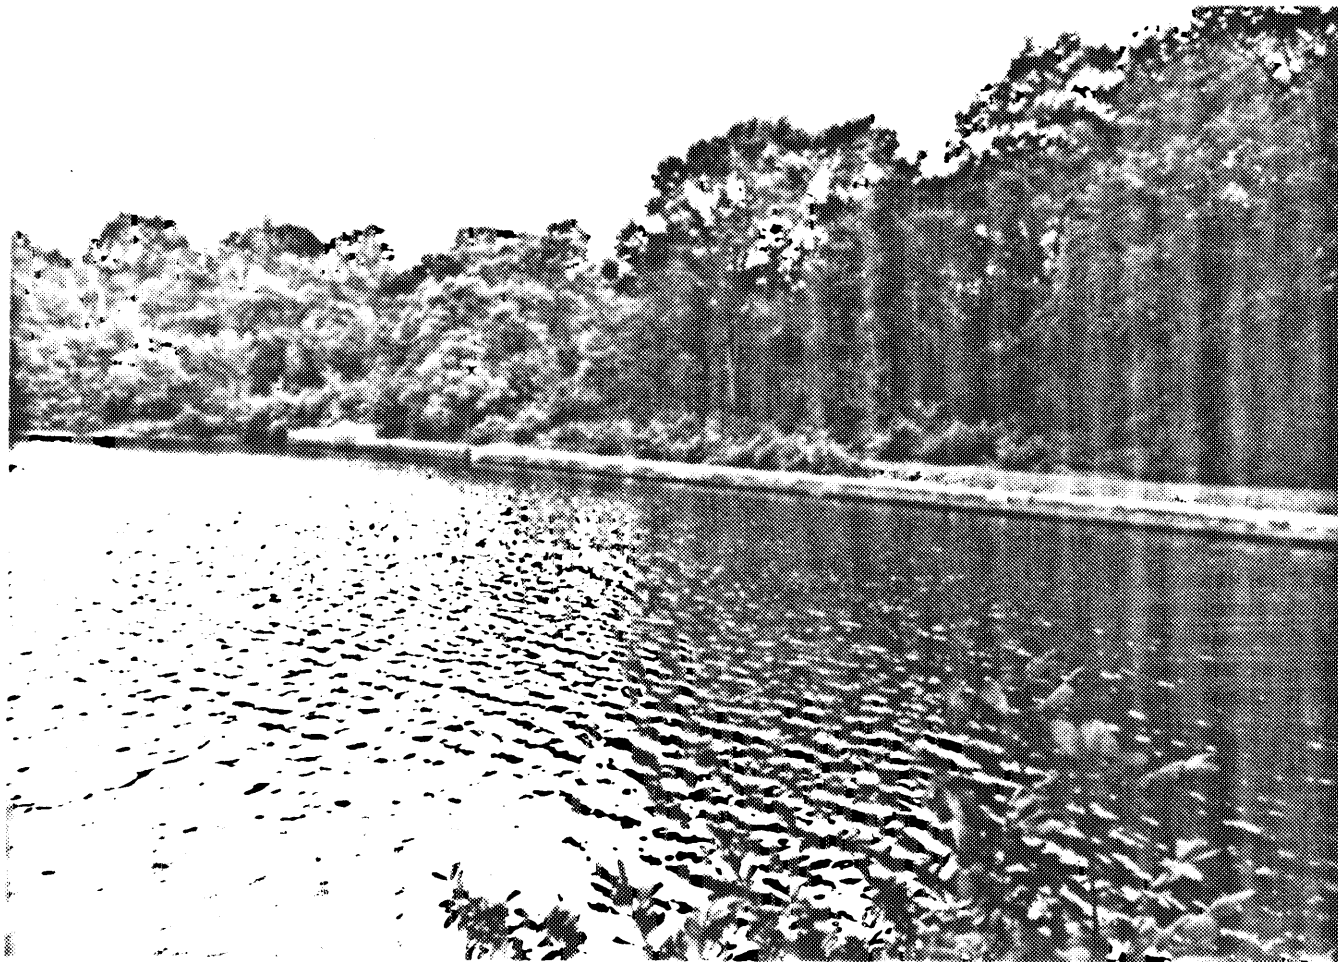
OVERVIEW PHOTO
(February, 1980)

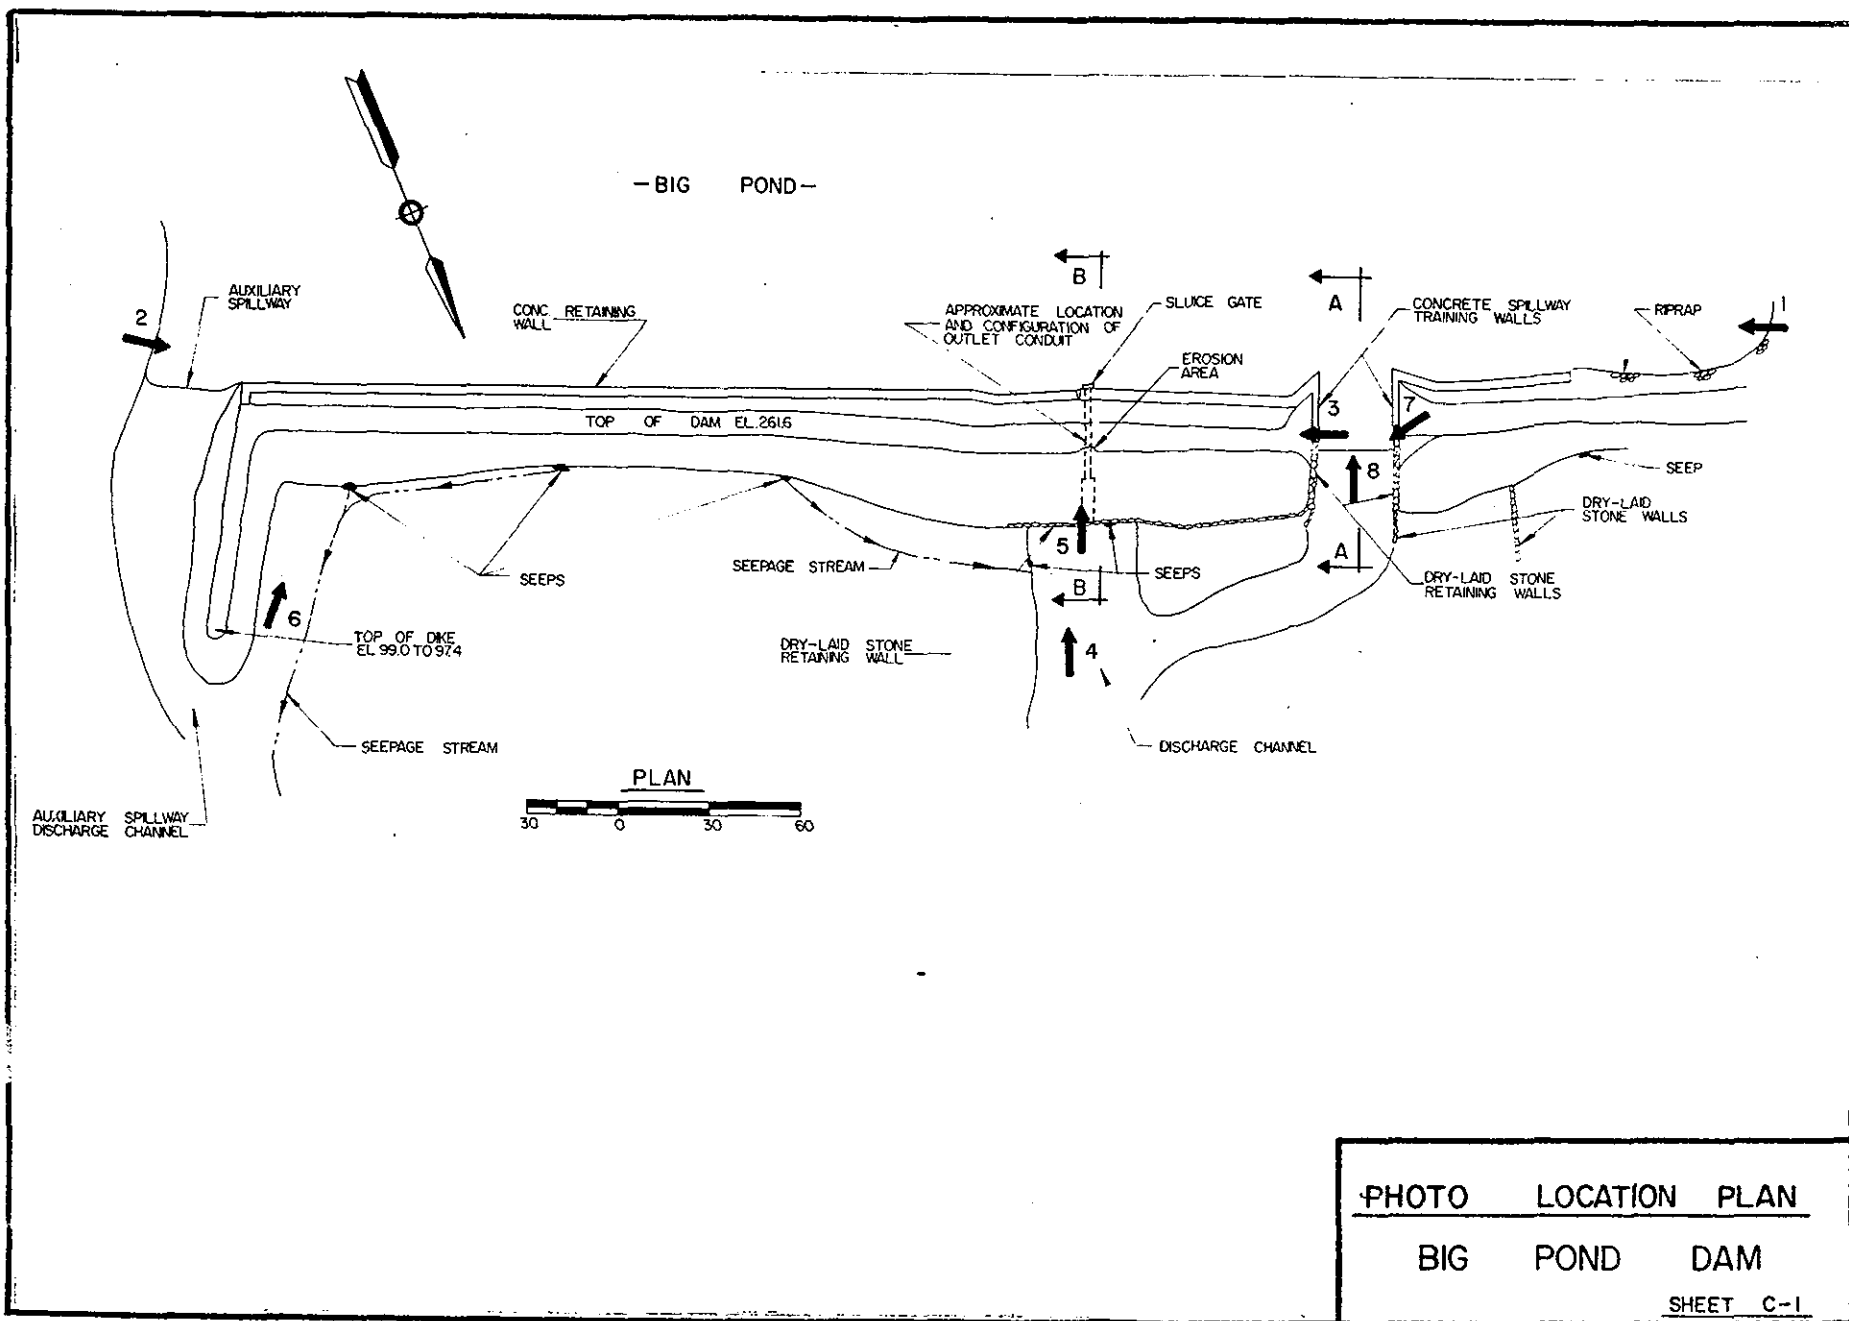
Upstream Slope - The upstream slope is the vertical face of several sections of concrete wall and a small riprapped section at the left end of the dam (Photos 1 and 2). The older section of concrete wall at the right end of the dam is severely spalled and deteriorated, with large cracks and exposed aggregate (Photo 2). The slope at the left end of the embankment has some missing riprap and exposed areas. The newer section of wall appears to be in good condition (Photo 1). The top of the concrete walls are 2-3 feet below the top of dam. The riprapped slope below the waterline could not be inspected.

Photo 1 - Upstream slope from left abutment. Spillway at upper center and outlet mechanism to right of spillway. (April, 1980)

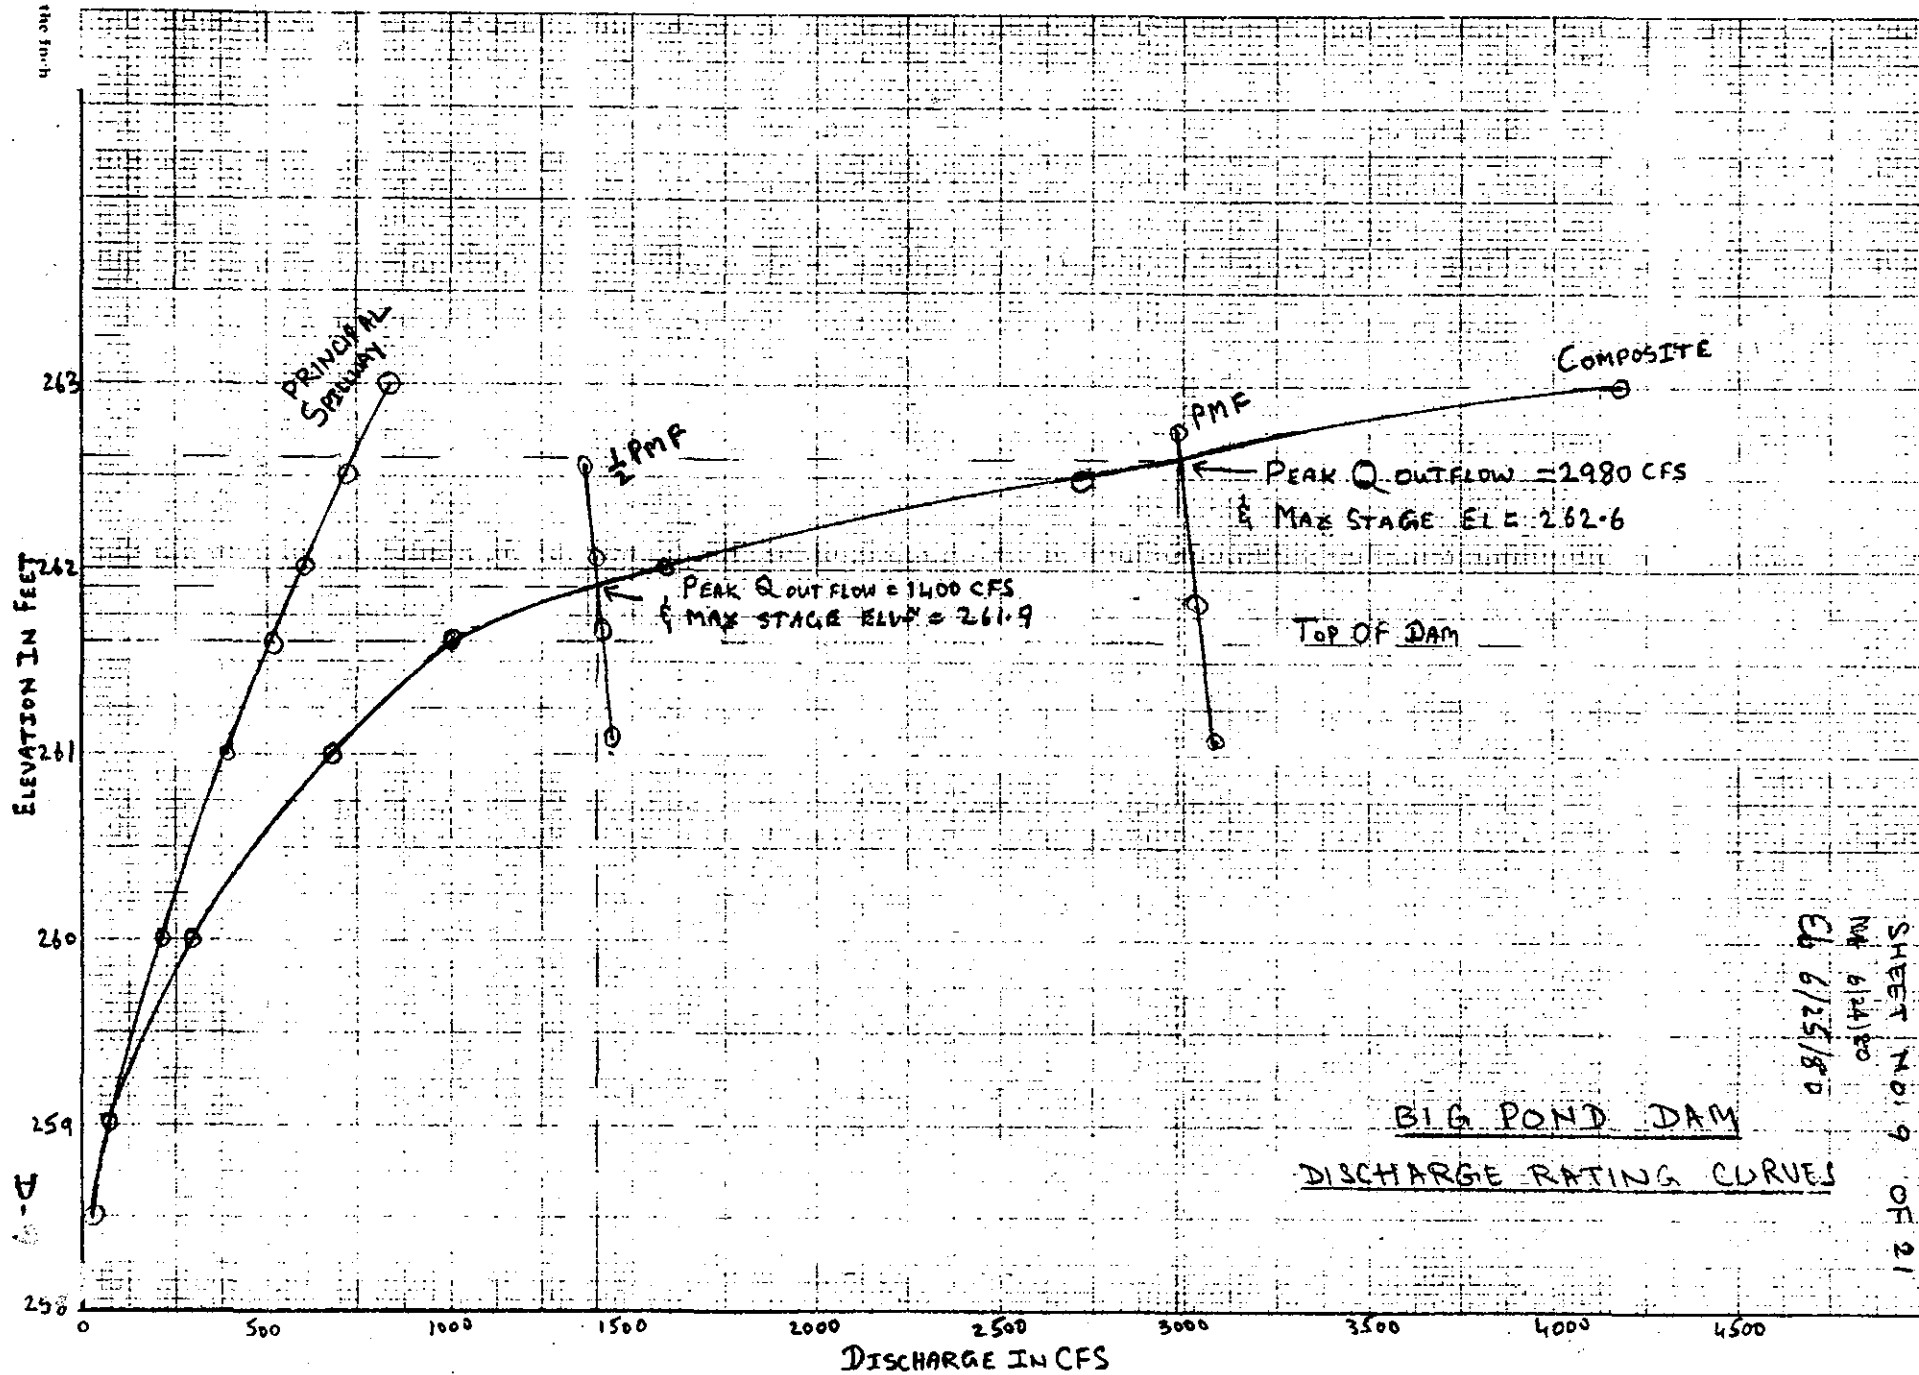
SHEET NO. 9 OF 21
 DATE 6/24/80
 E6 6/25/80

NOTE - 1. CONSIDERING THE TOTAL DISCHARGE CAPACITIES ABOVE, THE DISCHARGE CAPACITY OF THE LOW-LEVEL OUTLET IS NEGLECTED. WITH THE ABOVE DATA DISCHARGE RATING CURVES ARE PLOTTED (SHEET 9.)
